Problem with +12V – 1A and +5V – 1A SMPS design

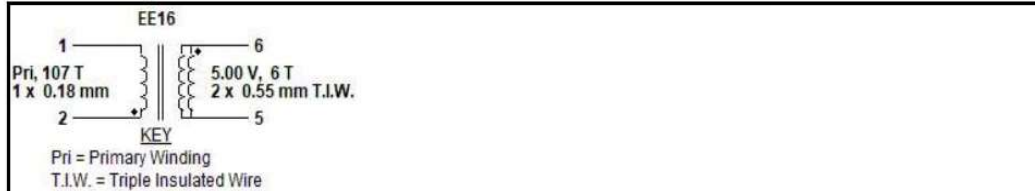
Electrical Diagram

b. Transformer Winding details

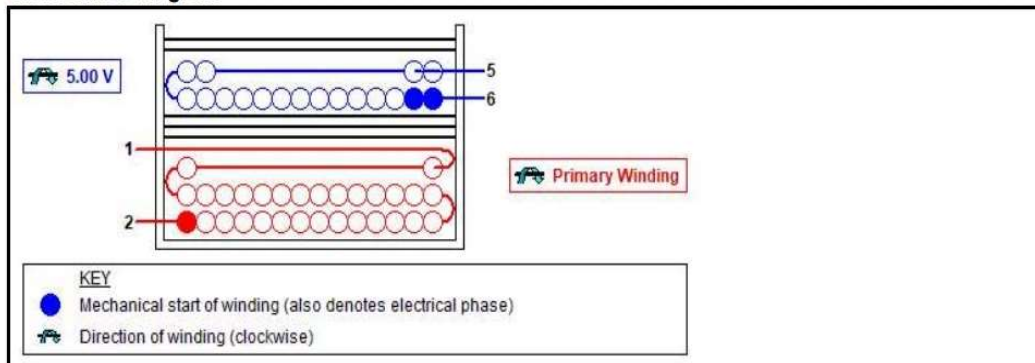
Mechanical Diagram

Winding Instruction

Primary Winding

Start on pin(s) 2 and wind 107 turns (x 1 filar) of item [5], in 3 layer(s) from left to right. Winding direction is clockwise. At the end of 1st layer, continue to wind the next layer from right to left. At the end of 2nd layer, continue to wind the next layer from left to right. On the final layer, spread the winding evenly across entire bobbin. Finish this winding on pin(s) 1.

Add 3 layers of tape, item [3], for insulation.

Secondary Winding

Start on pin(s) 6 and wind 6 turns (x 2 filar) of item [6]. Spread the winding evenly across entire bobbin. Winding direction is clockwise. Finish this winding on pin(s) 5.

Add 2 layers of tape, item [3], for insulation.

Core Assembly

Assemble and secure core halves. Item [1].

Varnish

Dip varnish uniformly in item [4]. Do not vacuum impregnate.

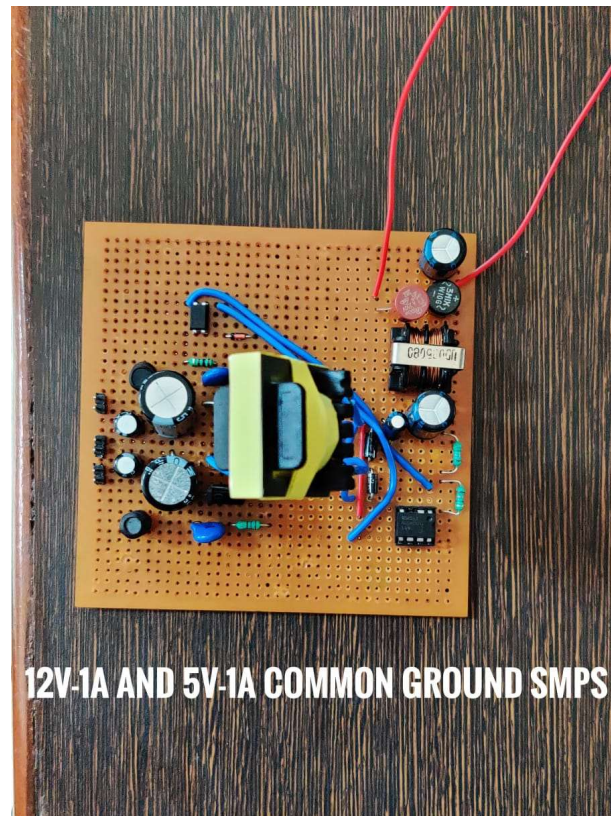
Circuit

The circuit was designed according to schematic and transformer winding “ was done by hand “ as per constructional details.

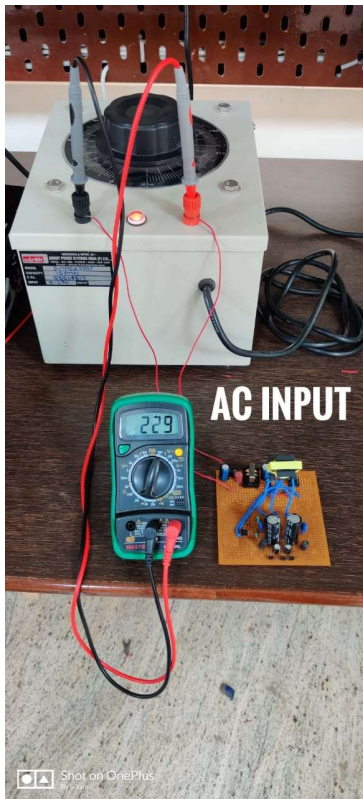
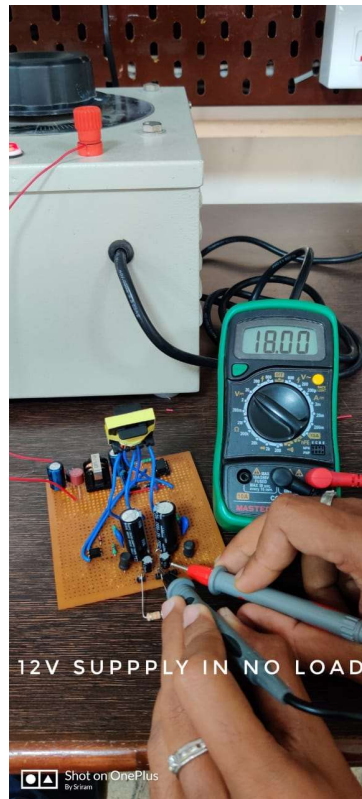
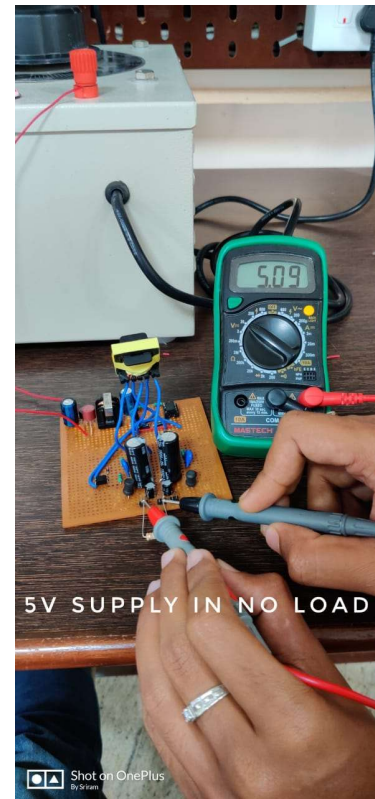
With AC input 230V, +5V – 1A output was stable whereas the +12V – 1A output was not stable in NO LOAD condition.

There is an instability in +12V – 1A output of SMPS, even though +5V – 1A is stable in both load and no-load conditions. Changing the value of bulk capacitor and pi inductor value at output had no significant improvement.

Cause of this instability is still unknown.

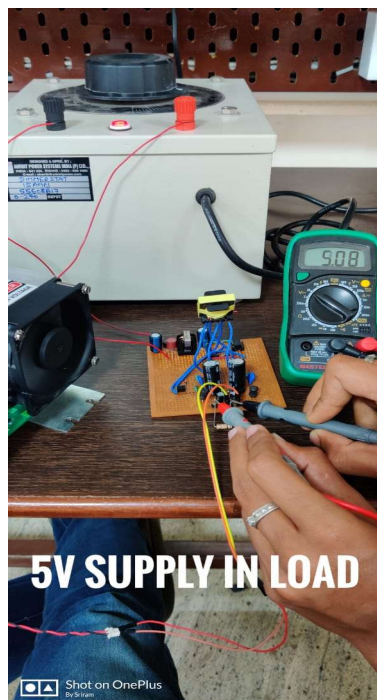
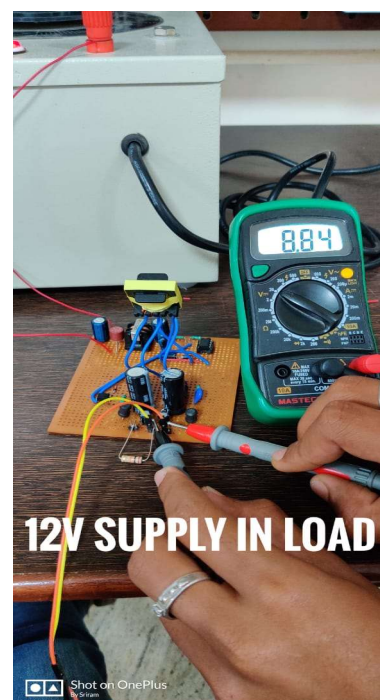
In Load Condition

Load = 12V – 600mA DC Motor was used as load.

+15V – 1A dropped drastically with load voltage dropping to +8.8V, whereas +5V – 1A output was stable in those load condition
